DP Class 3 MODU exceeded WCF while operating with open busties during a heavy weather event

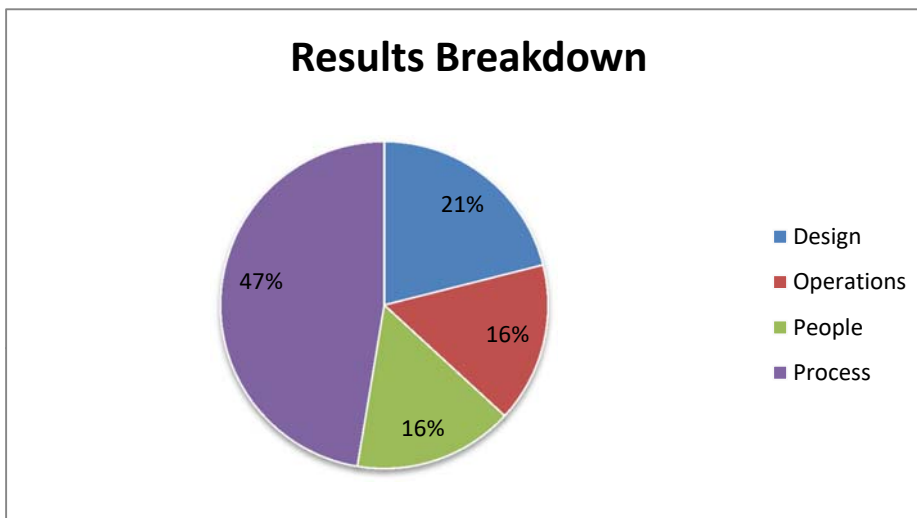
The chart below shows the breakdown of the identified causal and contributory factors as defined within the four criteria of Design, Operations, People and Process.

Design	4
Operations	3
People	3
Process	9

The results suggest the contributory factors were mostly related to process failures
