BLACK OUT ON A DP 2 CLASS VESSEL OPERATING WITH AN ASOG AND A SEGREGATED POWER PLANT

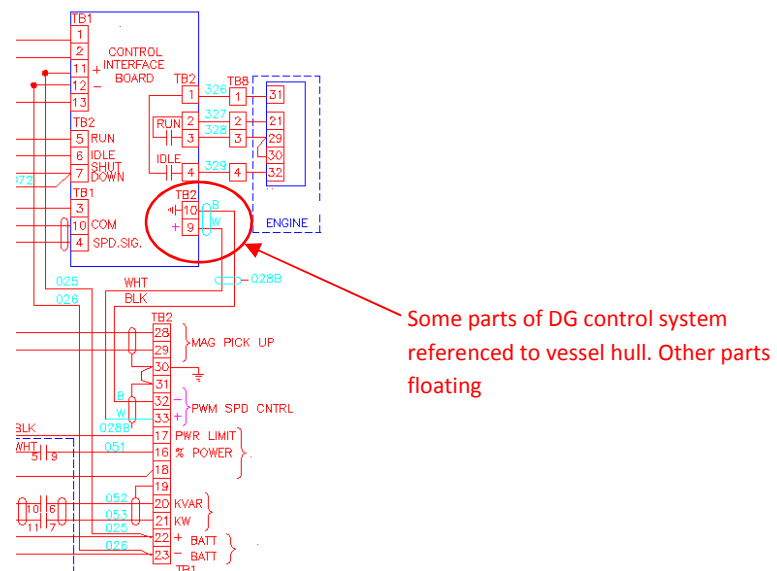
FIGURE 1

Grounding/Earthing arrangements for generator control supplies, on the engines and within the main switchboard, were a mix of floating and hull referenced ground points as shown in Figure 1.

Investigation revealed a 30 ohm impedance from each engine to the hull indicating that the 24Vdc electrical control power systems were not fully floating as originally thought.

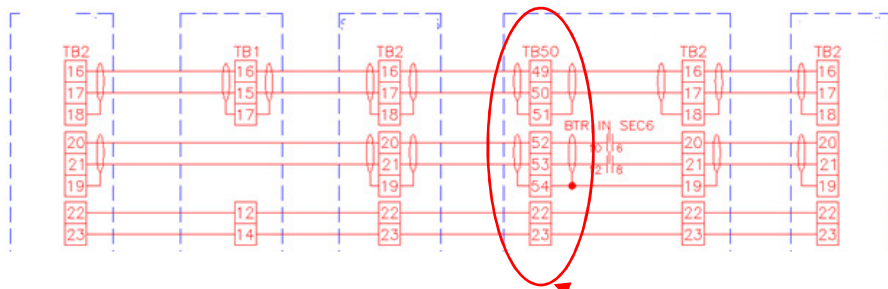
FIGURE 2

When the earth fault occurred, the commonality in the switchboard wiring allowed the voltage on the negative supply rail of the floating 24Vdc systems to be raised with respect to those parts of the control

system that were referenced to the vessel's hull causing a malfunction which stopped the engines of DGs 1,2 and 4. See Figure 2.

The 24Vdc battery charger output circuit breaker did not trip suggesting that the current was low and confirming the fault was not a short circuit.

Several potential fault propagation paths created by control wiring between generators and redundant DP equipment groups

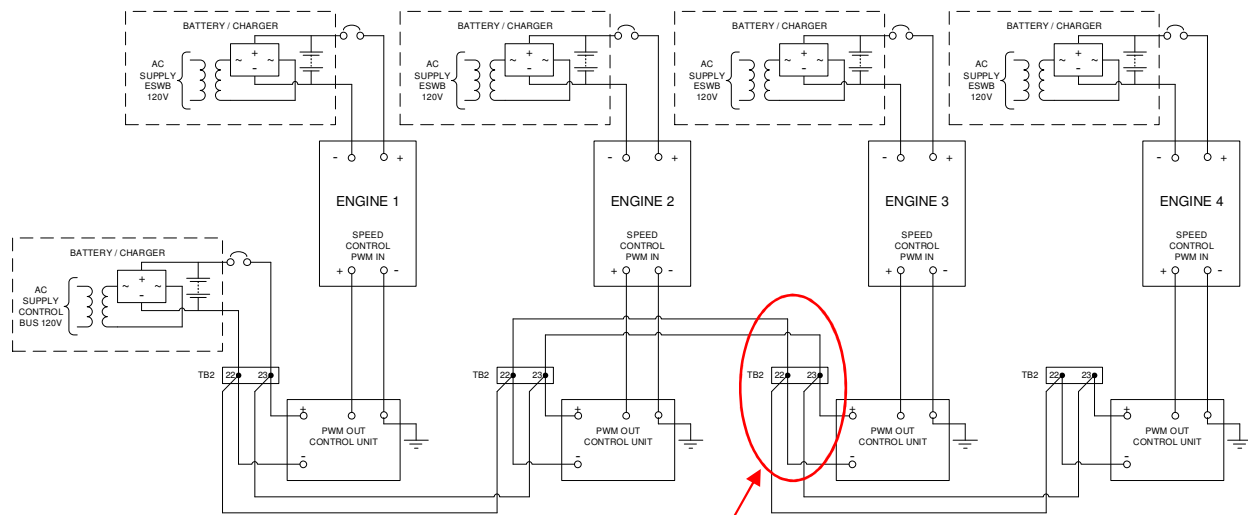
FIGURE 3

The investigation revealed another potential fault propagation path which could have resulted in the same consequence. This failure mode was created by a common black start battery system spanning all redundant DP groups. See Figure 3. The full extent of the threat posed by this potential fault propagation path had not been captured in the DP system FMEA.

Potential fault propagation path introduced by common black start battery supply
