## **Diving Vessel Drive-off - Propeller Failure to Full Pitch**

### **Vessel Particulars**

- DP Class 2 - Mono-hull diving support vessel
- Main propulsion provided by engine driven Controllable Pitch Propellers (CPP)
- Electric tunnel thrusters driven by shaft generators

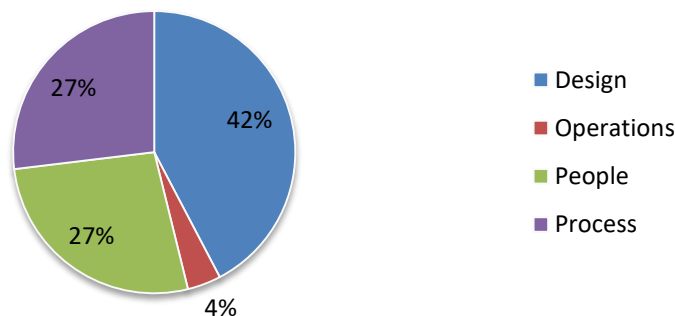
### Results Breakdown

The MTS LFI tool produces a breakdown of the causal and contributory factors in the incident as defined within the four criteria of Design, Operations, People and Process. The results in the chart below suggest that deficiencies in equipment '*design*' and their associated verification '*processes*' had the most significant contribution. Although '*people*' also featured in the results, lessons learned from this and similar incidents confirm that operators may not act in a predictable manner during a developing DP incident and methods should be sought to eliminate this hazard through design.

<b>Design</b>	<b>11</b>
<b>Operations</b>	<b>1</b>
<b>People</b>	<b>7</b>
<b>Process</b>	<b>7</b>
