DYNAMIC POSITIONING CONFERENCE
October 12-13, 2011

DP Drilling Operation Success -
Electric Pod Thrusters Extend Maintenance Intervals

By Jukka Varis & Eero Laakkonen
ABB Marine, Helsinki, Finland

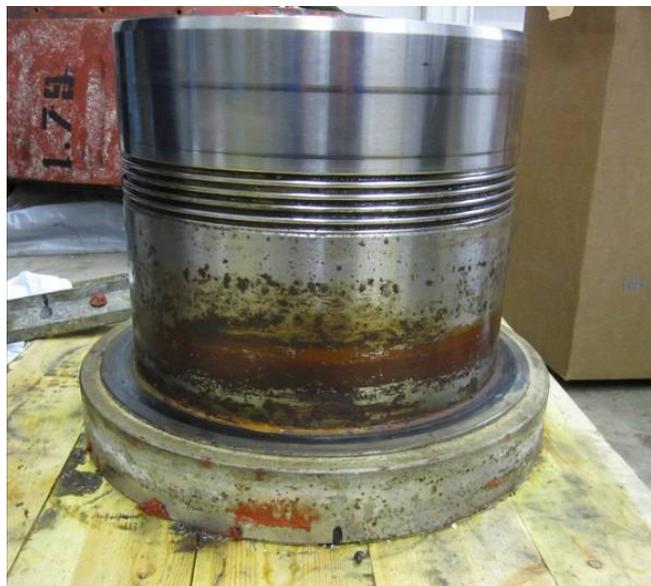
Visible grooves have been found in the liner of the lips seals (refer to the image below), but they have not been so deep that seals would not be capable of continuous operation. In a couple of the thrusters, there have been signs of crevice corrosion between the liner and the propeller shaft. These corroded spots have been repaired during overhaul and the assembly process quality assurance protocols have been improved to mitigate the risk of crevice corrosion under the shaft seal liner.

Disassembled seal liner

Liner material has also been changed to further increase the lifespan, and the intermediate sleeve material has been changed to avoid possible corrosion of the sleeve. On the secondary seal, a third seal lip has been added to increase the lifespan and redundancy of the seal package, and the lip material has been changed to reduce the seal hardening during aging.

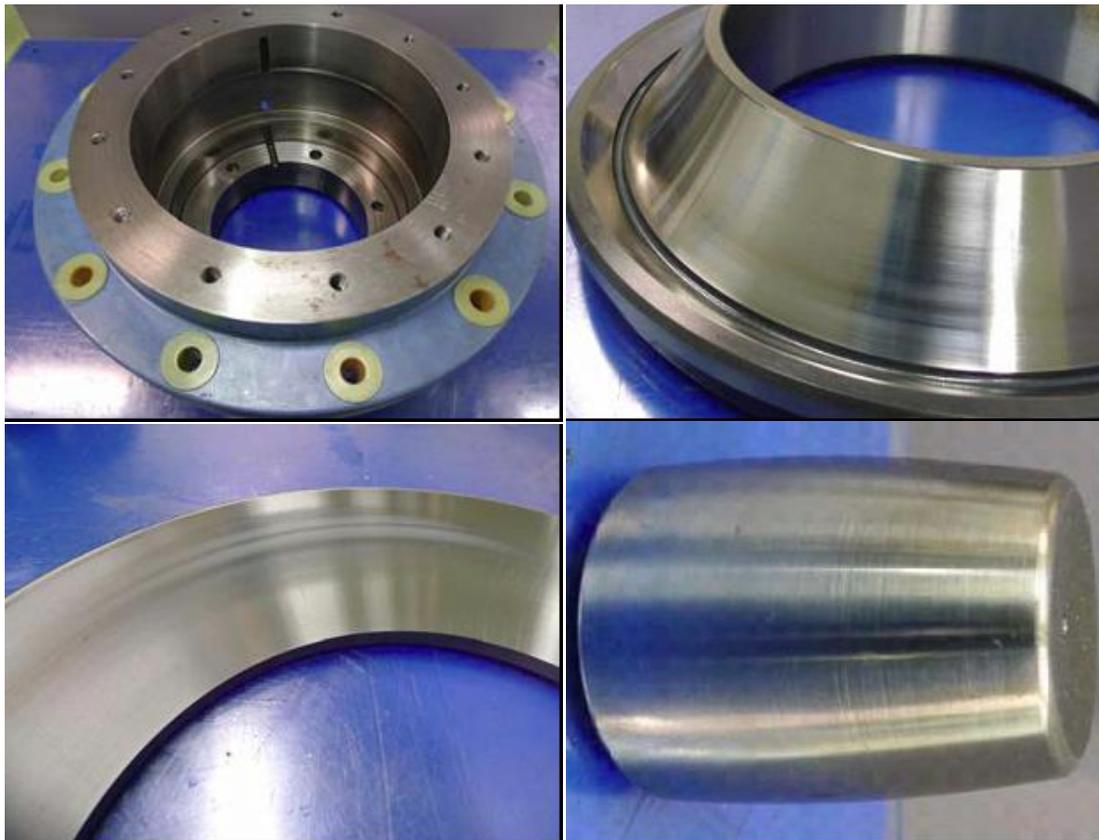
There have been visual circumferential path patterns in all of the raceways of the thrust bearing unit, and the same kind of circumferential lines can also be seen in the rollers (refer to the images below); however, this wear has been only a polishing of the surface, and has not yet caused any grooves affecting the performance of the bearing. The inboard seals of the bearing units have been in good condition, with no signs of oil leakage from the seals.

Disassembled Thrust Bearing (from upper left corner: housing, inner race, outer race, and roller)

The bearing manufacturer has stated that bearings are in good condition and capable of continued operation. The housing parts and the sleeve have been re-used, while the raceways and rollers have been replaced.

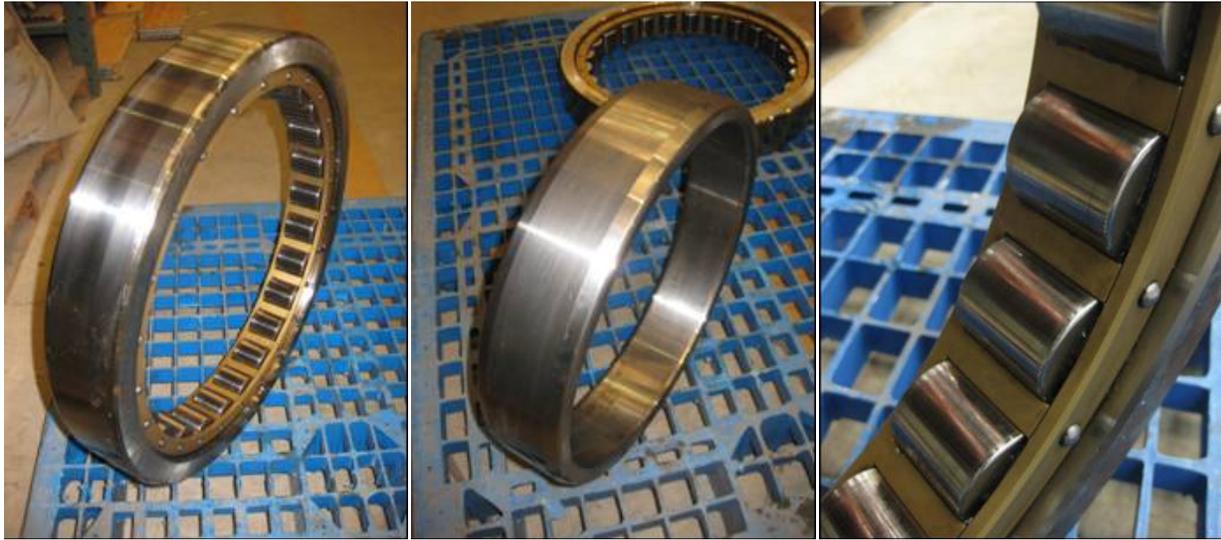
Drive end bearings, also known as propeller bearings, have all been replaced during thruster overhauls (refer to the images below). All the replaced drive end bearings have been in very good condition and would have been capable of continued operation.

Disassembled DE-bearing (outer race, inner race, cage and rollers)

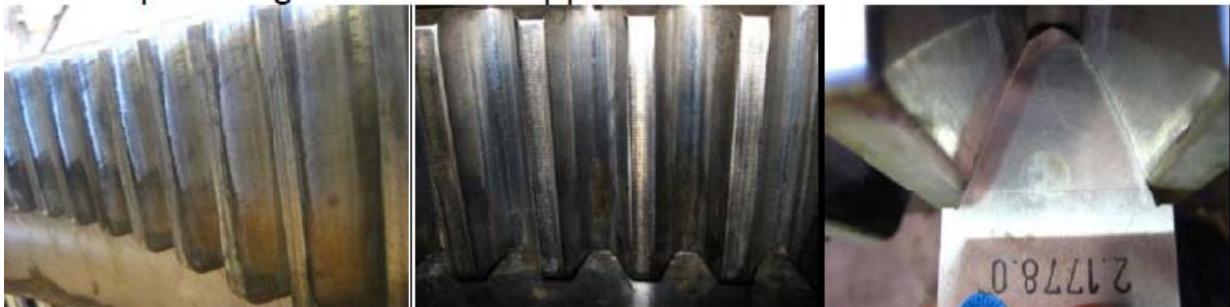
Slewing gears have been in good condition (refer to the images below). Gear tooth mating has been good, and only cleaning has been performed during the overhaul.

Slewing gear teeth

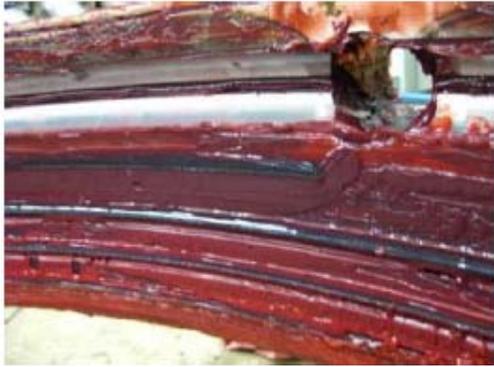
During operations, no major leakages have occurred from the slewing seals. On disassembly, there have been visible grooves in the sealing liner (refer to the images below), but the seal profile and liner has still been in such good condition that the sealing could have been used for a longer period; however, all the seals have been replaced in overhaul and the liner has been polished.

Slewing seals after disassembly

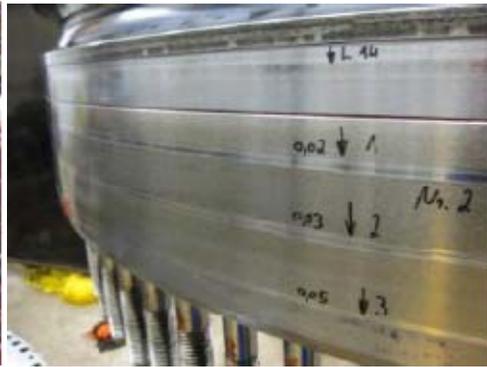
Slewing seal liner

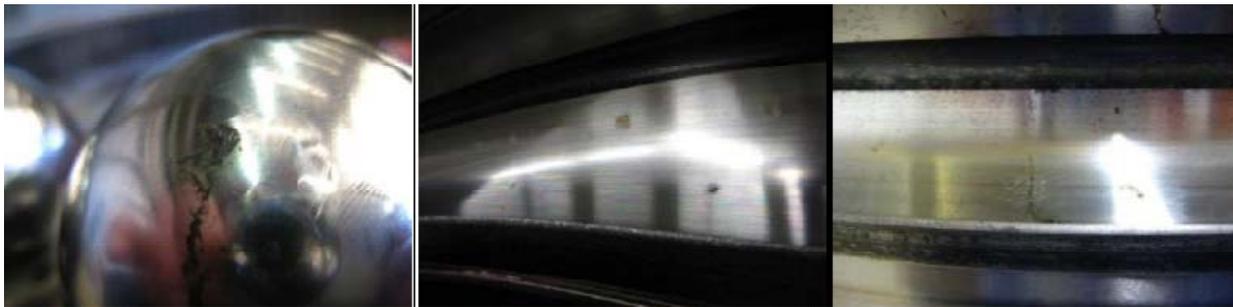
Slewing bearings have been generally in good condition. When the bearings have been dismantled, the elements have been polished to remove small wear-and-tear marks and then reassembled with old elements (refer to the images below). Some bearings have shown marks of etching and corrosion and, in those cases, the bearing balls have been replaced and the raceways polished. Even though there have been marks of corrosion, all the slewing bearings have been in operative condition. No changes have been noticed in torque needed by steering motors when rotating the thruster.

Slewing bearing components during maintenance

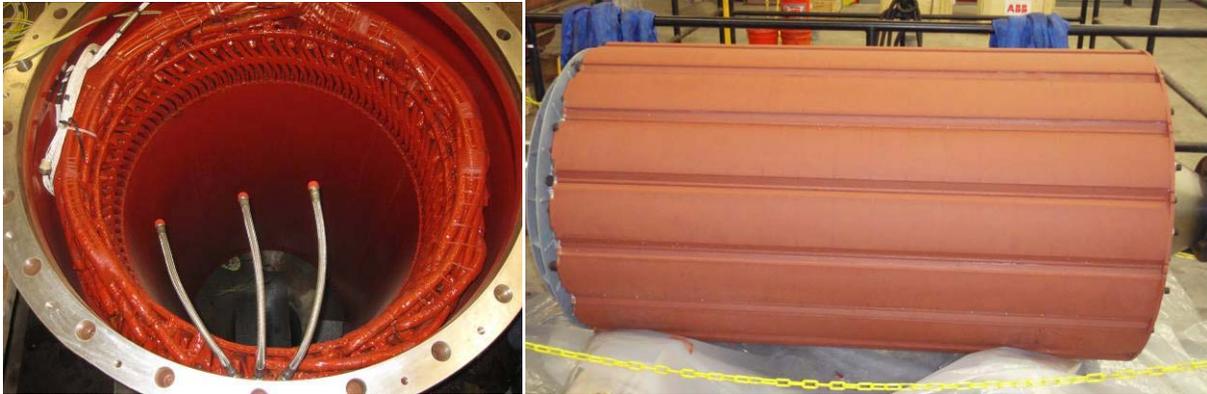
The permanent magnet motor typically does not require much maintenance. When thrusters have been dismantled in the maintenance facility, it has been easy to clean and re-lacquer the stators and the rotors, even though this procedure is not mandatory for the motors (refer to the images below).

Disassembled stator and permanent magnet rotor
