DYNAMIC POSITIONING CONFERENCE
October 11-12, 2016

**"Fault Ride-Through" Testing of a LV
Power Solution, BlueDrive PlusC**

Fault Ride Through Testing of LV Power Solution BlueDrivePlusC

By Stig Olav Settemsdal, Lars Barstad, and Kenneth Tjong
Siemens AS, Offshore Solutions

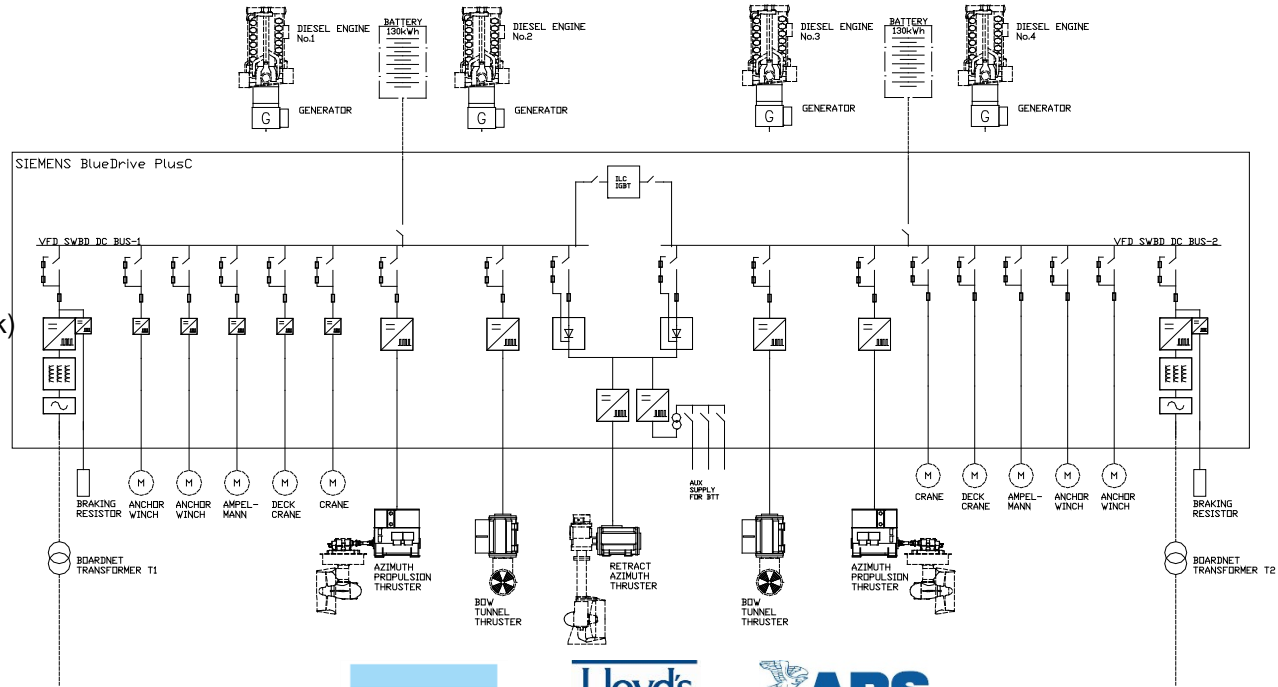
BlueDrive PlusC Main building blocks of the LV power solution

DC power distribution system

DP operation with a closed bus tie (ILC breaker)

Variable speed generators

Integrated rectifiers

Integrated frequency converters

Integrated Ship-net supplies (clean power network)

Integrated auxiliary VFD or DC feeds

Dual Thruster feed

Optional energy storage solutions
(battery or super caps)

Water cooling systems

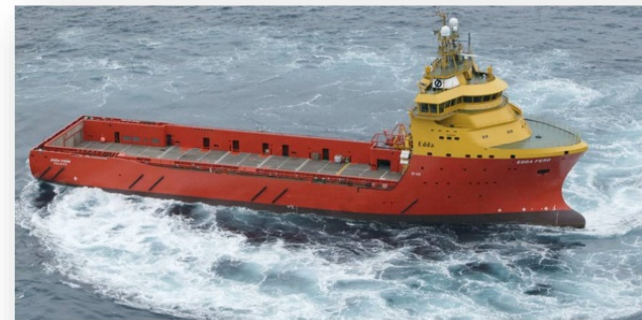
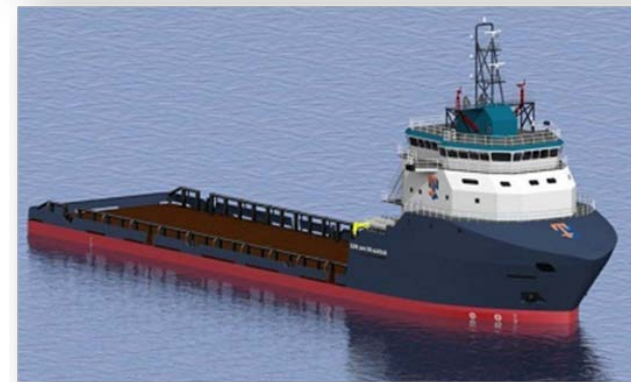
BlueDrive PlusC

The tested power system

Fault location

The fault was injected at the STB FIFI pump No2, the fault was created by connecting a Siemens 3WL breaker in short circuit between + /- after the fuse of the FiFi pump inverter.
The breaker was closed remotely

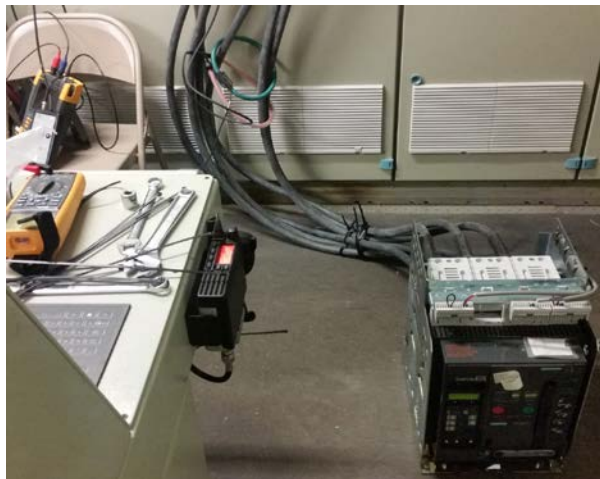
The circuit breaker creating the short circuit

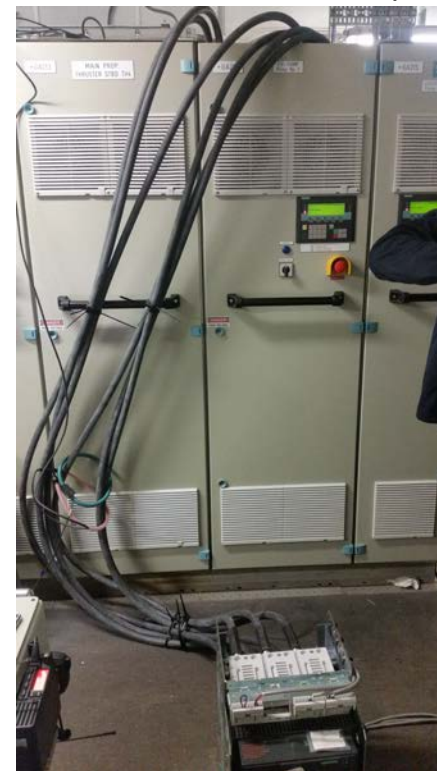
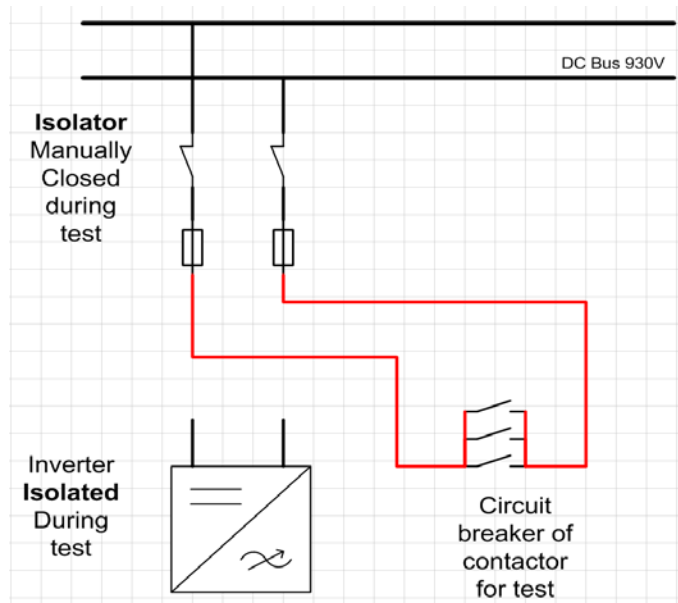
Test monitored by two Current measurement with two oscilloscopes

Simplified view of the fault circuit

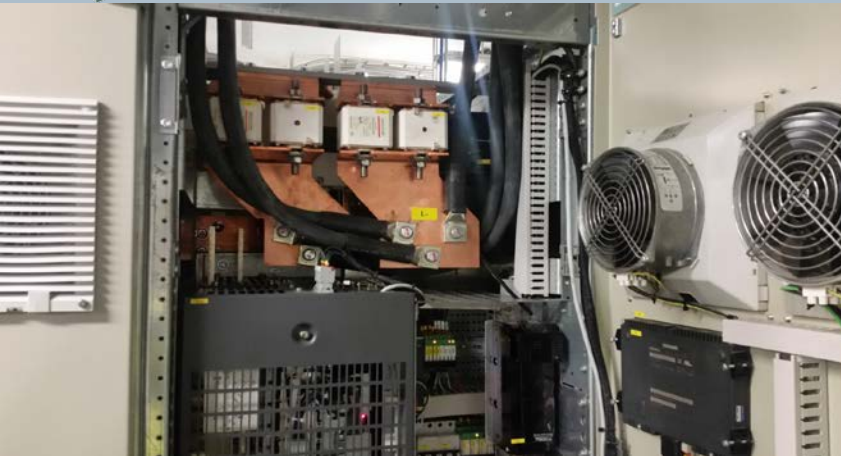
**Cables connected below fuses,
motor module for FiFi pump
disconnected**

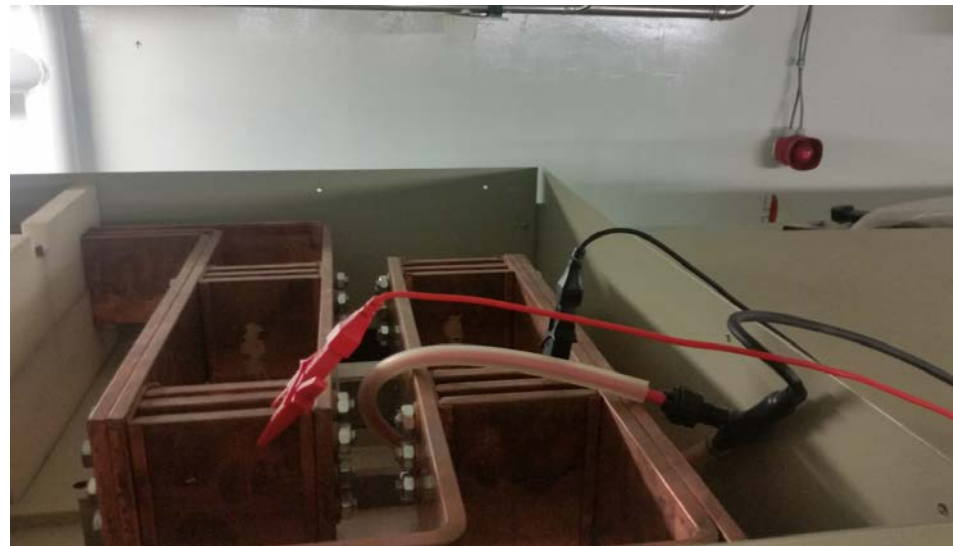
Current and voltage measurements over the
ILC bus-tie breaker

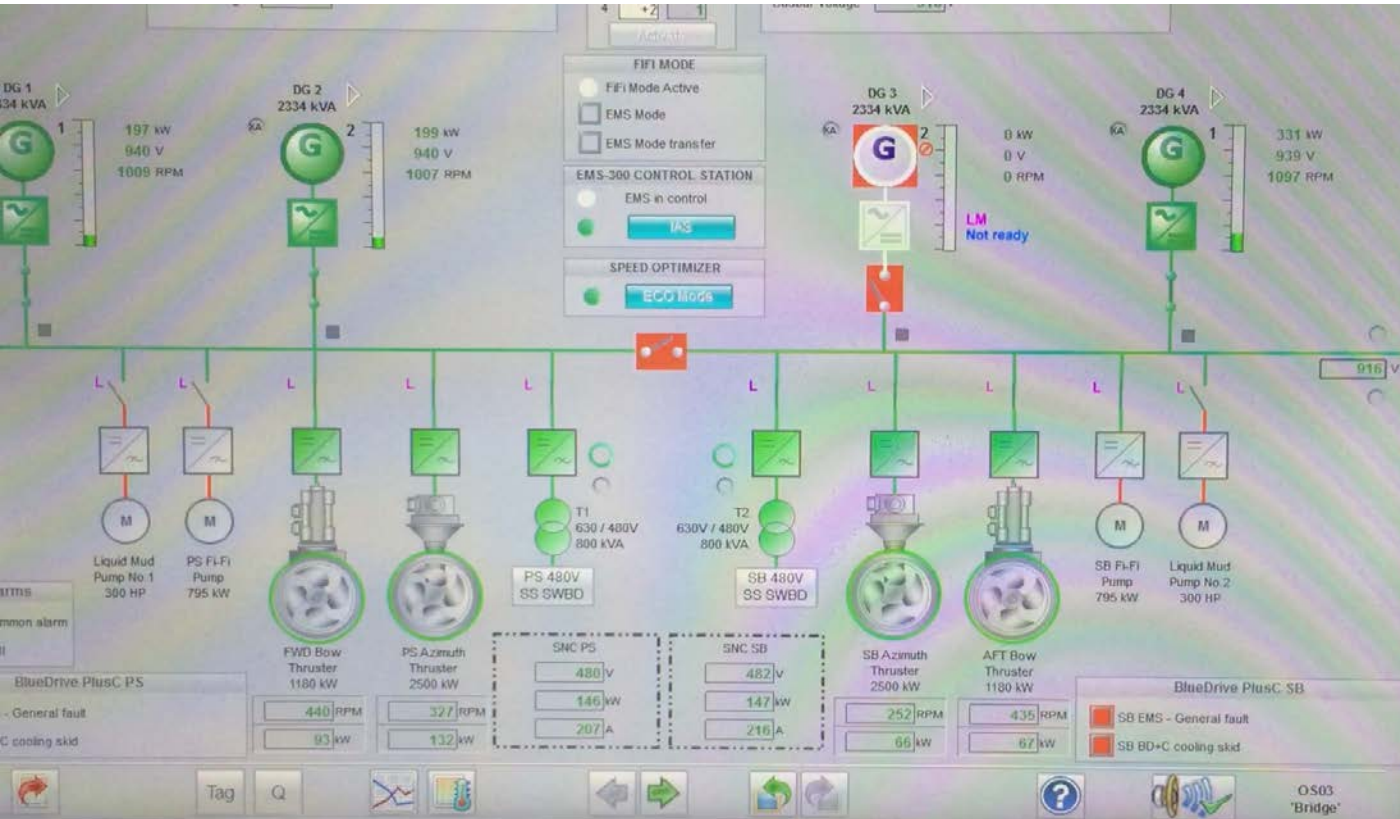
The vessel operation post fault

Two generators on one side and one on the other in operation during the test.

Result:
Tripped bus-tie and four fuses (2 per pole) blown in the cabinet with the fault.

The rest of the system was fully operational.

- ✓ Fault ride through testing of the first LV power system is now successfully performed during a vessel SAT.
- ✓ The ILC bus-ties separated the power sections by tripping the short circuit fault within 20 μ s.
- ✓ This ultra fast tripping ensures that the healthy section does hardly notice the fault.
- ✓ Fast semiconductor fuses cleared the fault after 300 μ s.
- ✓ The section with the short circuit continued in operation.
- ✓ Tear & wear of the rotating equipment and the electrical equipment are negligible.
- ✓ This type of testing is shown not to be destructive in a BlueDrive PlusC LV power solution.
