DYNAMIC POSITIONING CONFERENCE
September 17-18, 2002

Dynamic Positioning Incidents
Resulting From Inadequate Power Systems Analysis

Don E. Wilkes, P.E.

GlobalSantaFe Corporation (Houston, Texas)

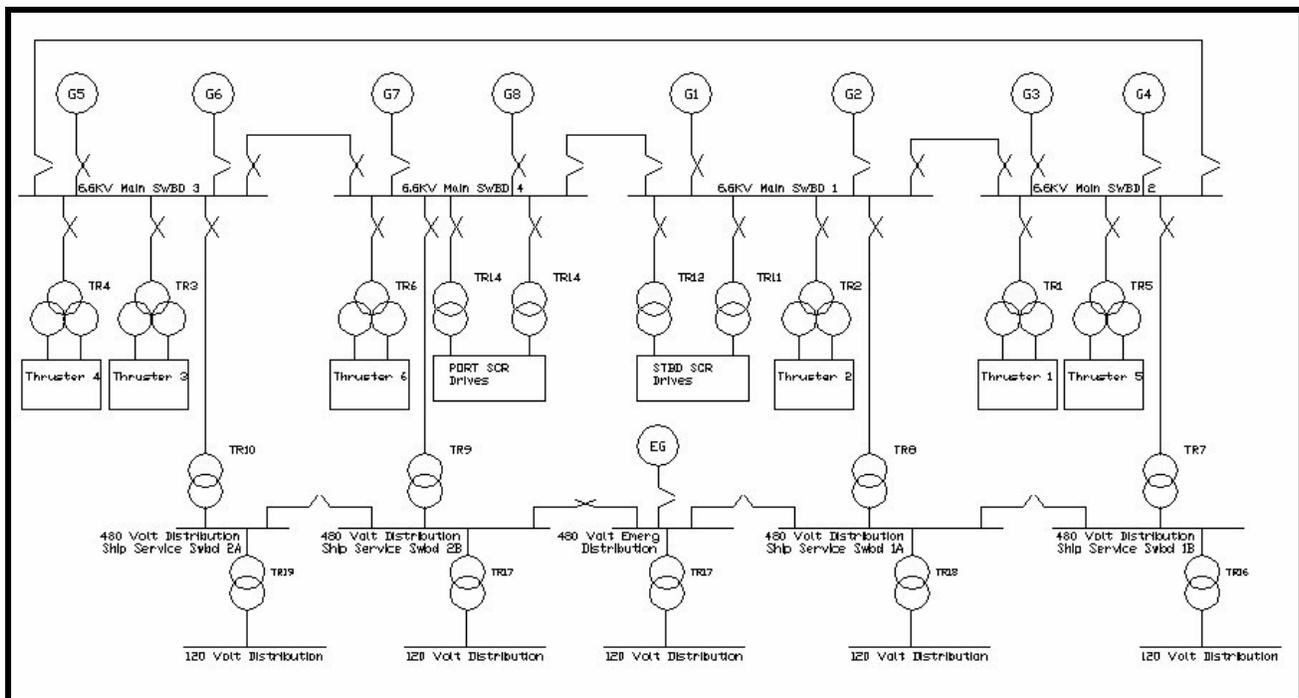
Figure 1

A typical basic Power System arrangement is depicted in the following diagram noted as Figure 1.

Note that there are four separate systems that may be operated individually or in a variety of combinations of these buses. An Emergency generator is also a part of low voltage distribution system. Details of the distribution are too complex to be incorporated here, but there are some features that deserve comment. The vessel has been classed as a DPS-3 vessel, arranged as two main engine rooms with auxiliary systems and propulsion systems arranged to support a dual power system arrangement. For this vessel typical operation is as a split power system with two HV busses but four LV busses to provide what is considered to be maximum reliability.

The support systems needed to operate the prime movers include redundant pumps for each system, operating with one on standby, and the power for the multiple pump motors is supplied from different LV busses including the Emergency distribution bus. With the arrangement it is easy to look at the distribution system and identify the equipment that would be unavailable if a transformer or major feeder circuit were to fail.
