**DYNAMIC POSITIONING CONFERENCE**  
October 17 – 18, 2000

**FPSO NORNE Close Proximity DP Operations  
with MSV REGALIA**

Ralph H. Benham  
*Global Maritime, Inc. (Houston, TX)*

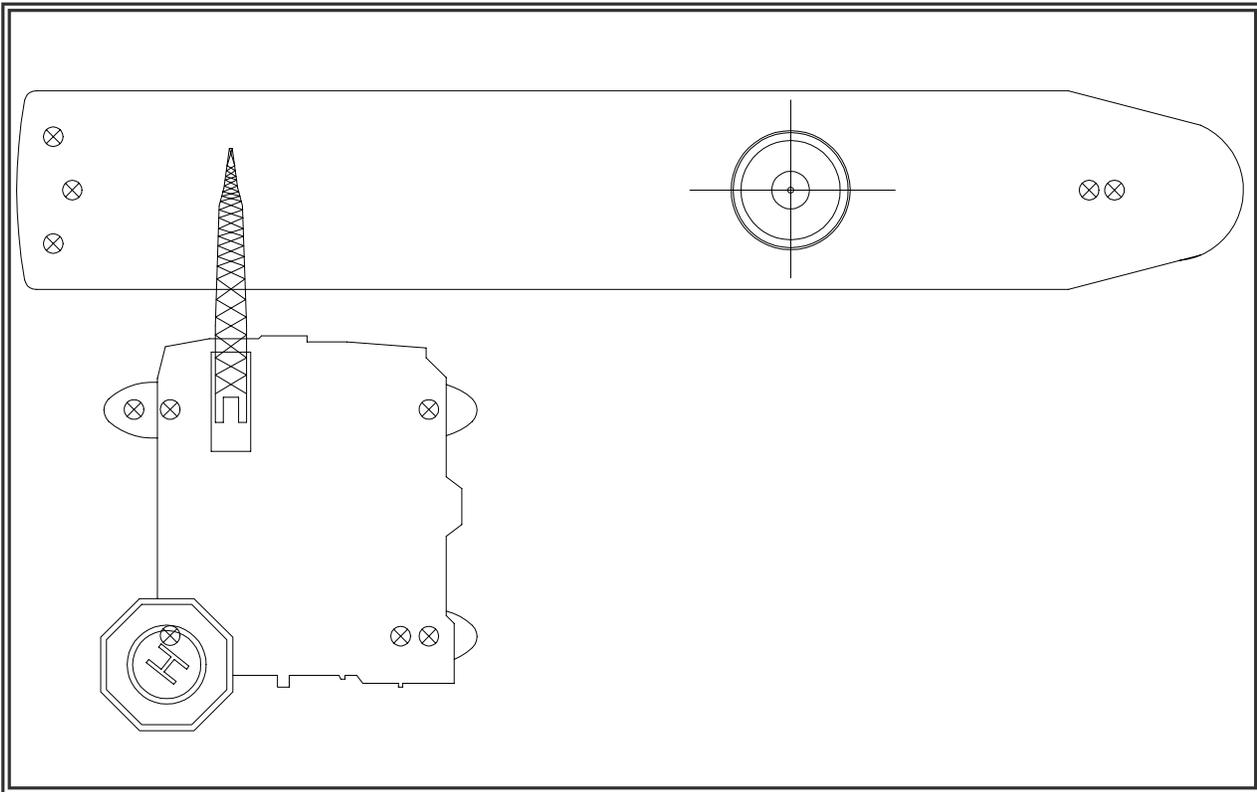
Vessel positioning for the TEG module lift.  
Heading control extremely critical.

There was a general agreement that any loss of position would result in collision, especially since the static clearance between the two vessels was going to be only 10m. This was especially true while installing the TEG module, and that was mainly due to the heading sensitivity of the FPSO. It was determined that a loss of heading of 4.8 degrees on the Norne would result in vessel contact. This event by itself most likely would not occur if all things were operating correctly. This changes, however, when the natural motions of the Regalia and the natural motions of the Norne are both taken into account. The vessel motion analysis and footprints presented showed that a collision could occur even without any failures. The only consolation was that since the vessels were so close, the impact velocity should collision occur, would be low and the consequences would have been correspondingly small.

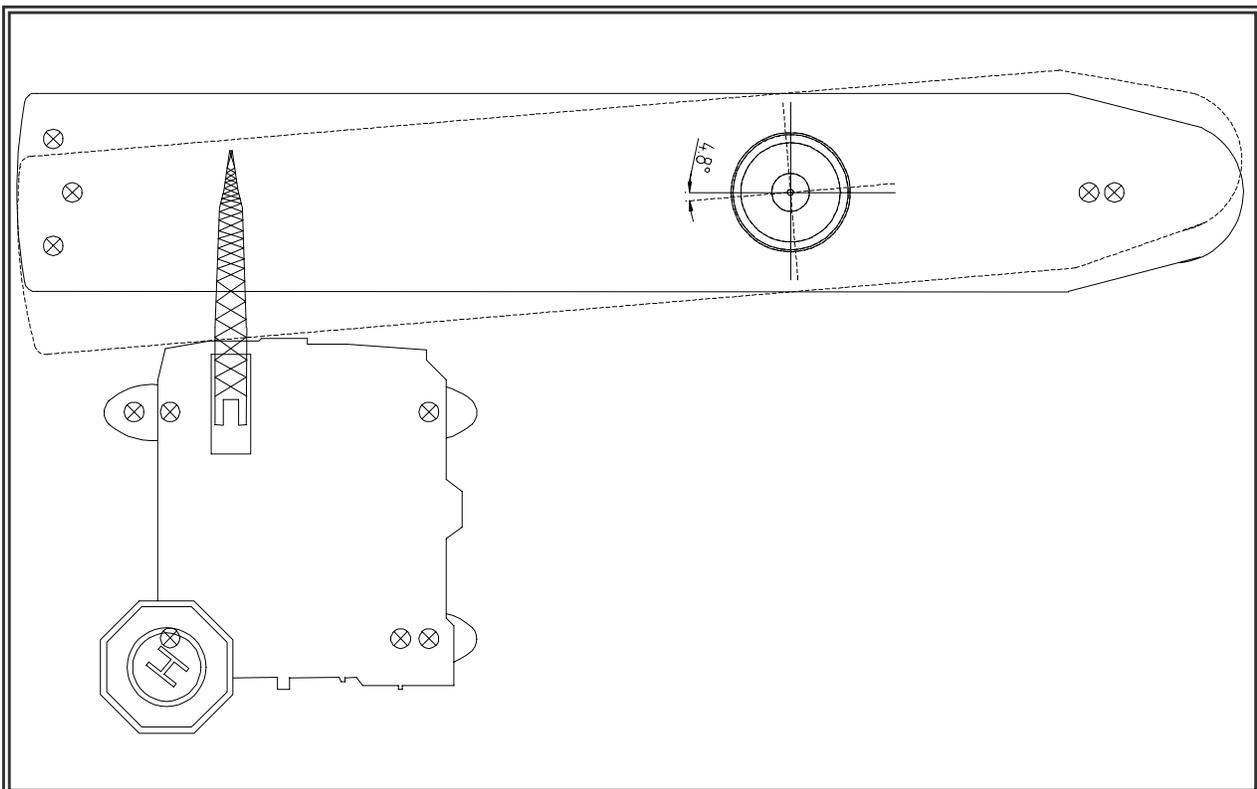
If a loss of position occurred during a setdown operation, the module could have made contact with the bumpers. Prior to set down, however, there was a relatively large clearance area above the bumpers so the crane operator would have therefore had sufficient time in most situations to swing the module around to have avoided contact with the FPSO topsides. Because of the tight set down space the most critical period was during the final stages of lowering the module.

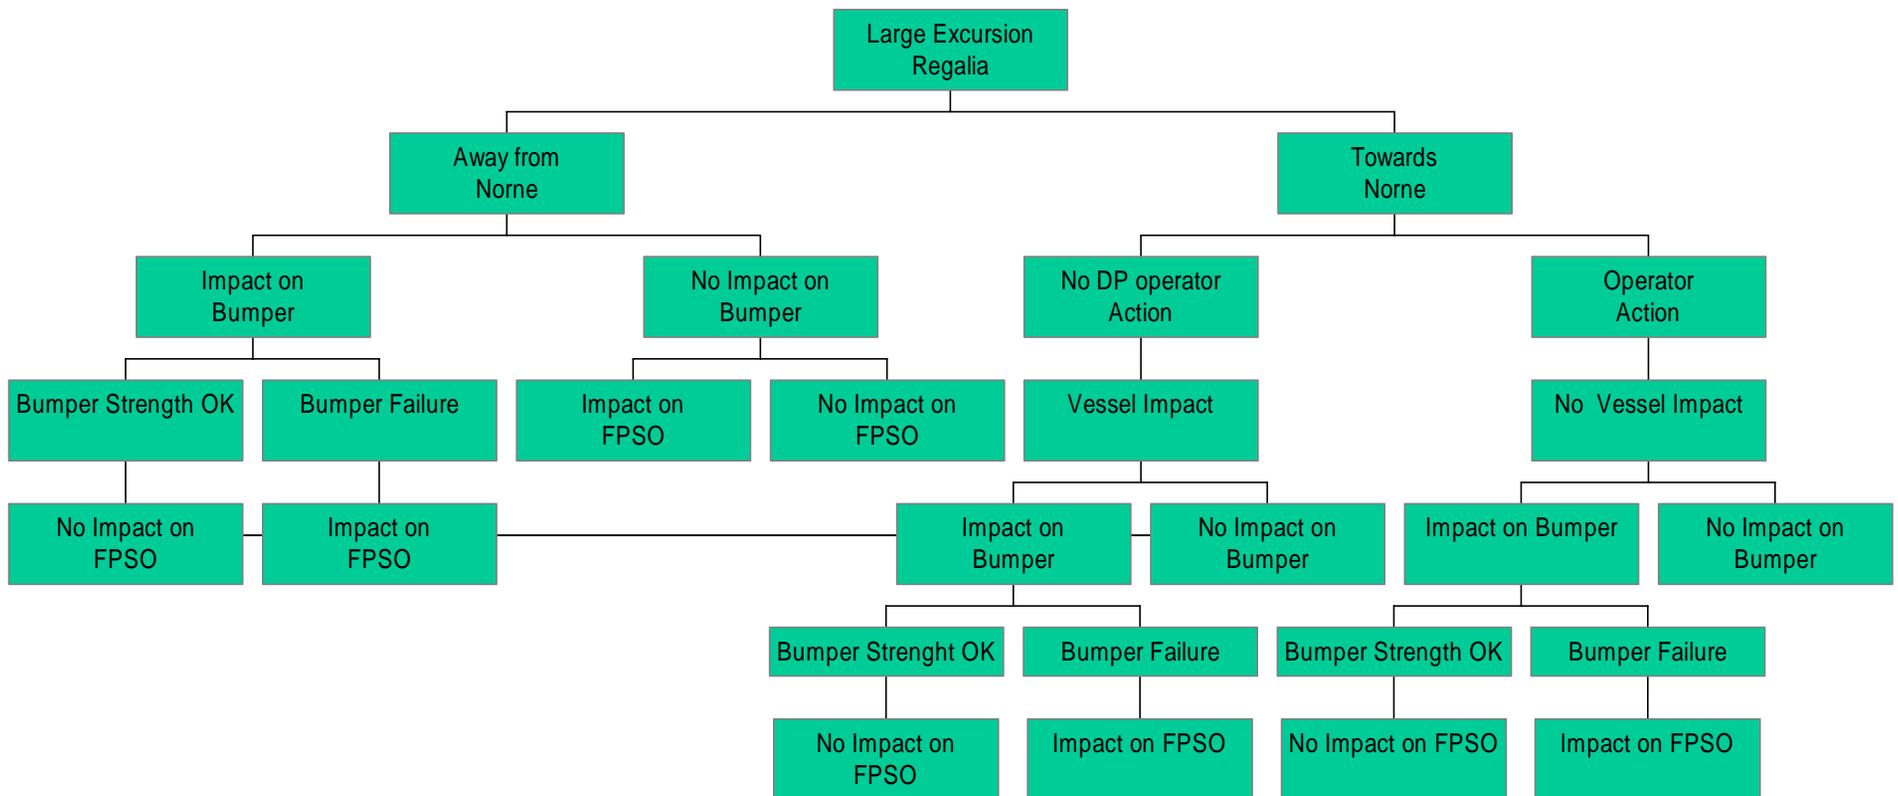
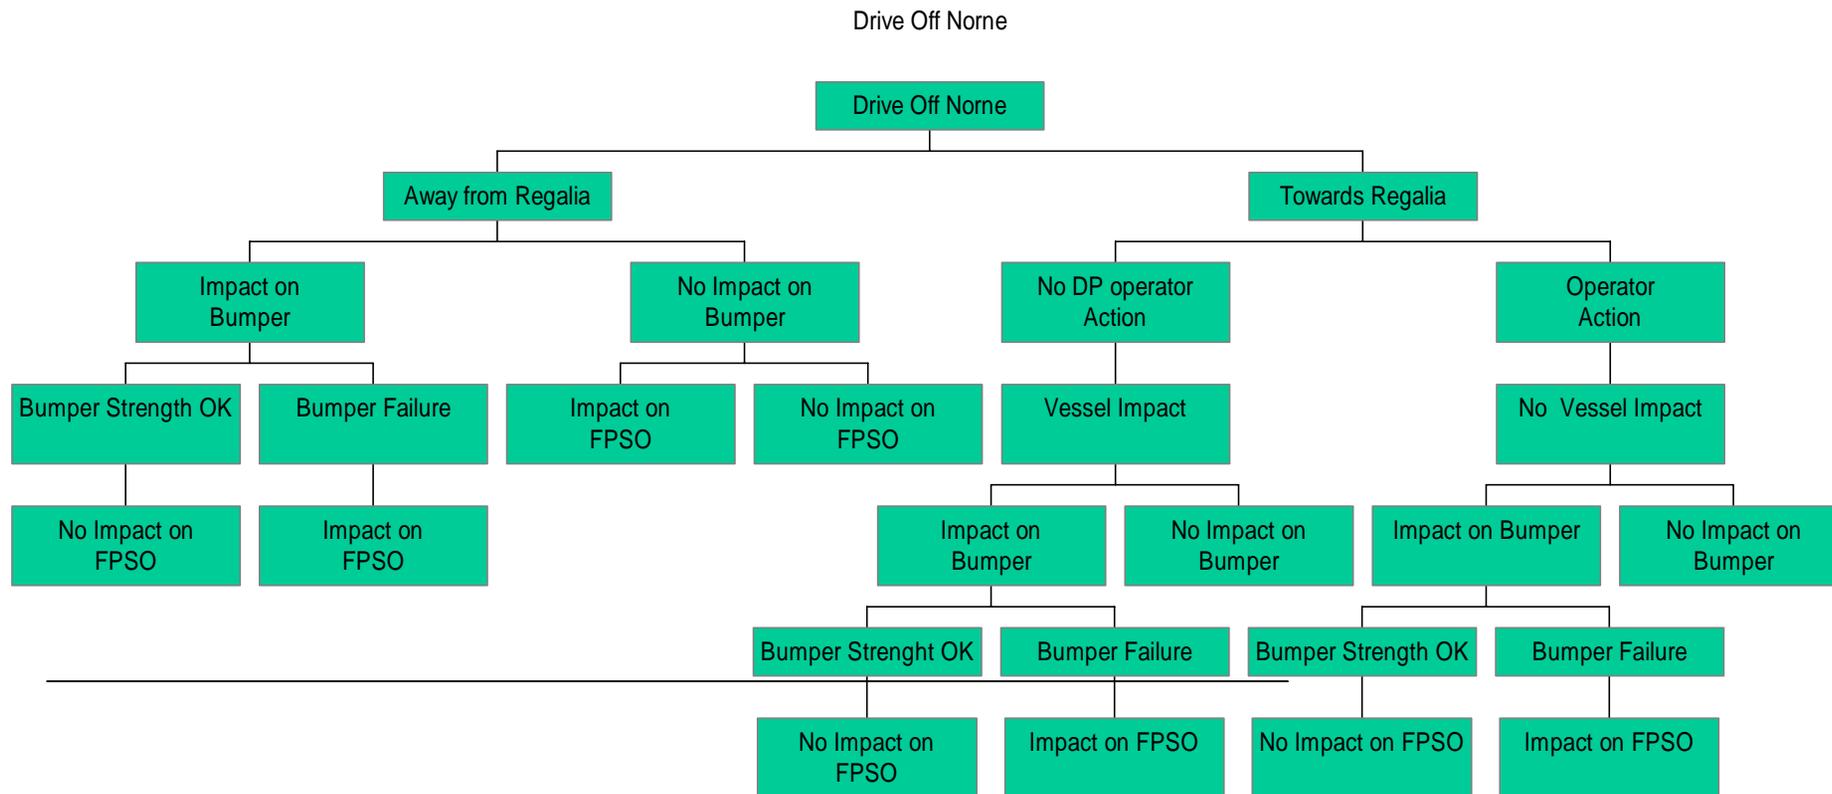
REGALIA LARGE EXCURSION

### **SELECTED EVENT TREES**
