**DYNAMIC POSITIONING CONFERENCE
November 15-16, 2005**

**Risk Analysis of a DP Diving Vessel Up Weather
Of Platform and Jack Up.**

**Doug Phillips and Jonathan Deegan
*Global Maritime (Houston) and BHP Billiton***

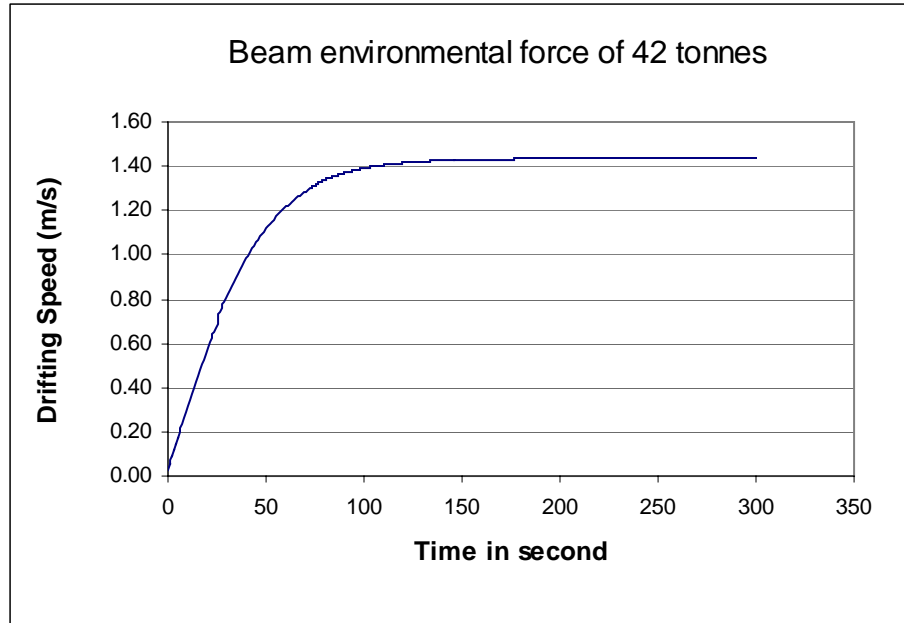
The drift curve for the 42 tonnes of environment using a 200 kN drag factor was as shown.

The vessel will be operating at up to 30 m from the platforms and as close as 10m, taking three points off the curve the impact velocities are

Distance from platform	Impact Velocity
10 m	0.73 m/s
20 m	0.96 m/s
30 m	1.1 m/s

Distance from platform	Impact Energy
10 m	3.77 MJ
20 m	6.52 MJ
30 m	8.56 MJ

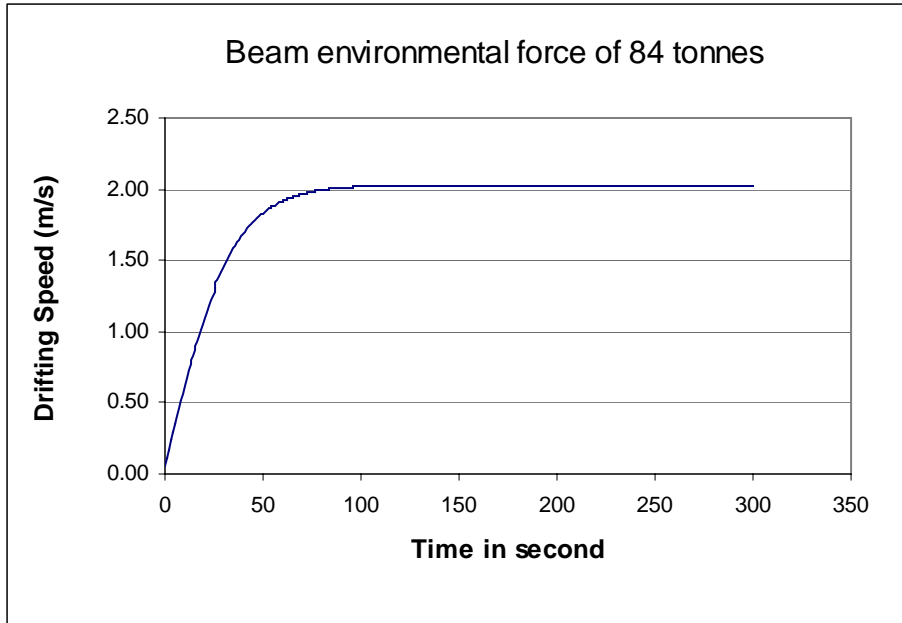
For the drive off situation it was be assumed that the vessel might drive off with twice the environmental force. The principle being that the vessel was approaching the limit of the environment and has a failure such that the vessel was driven of by the same amount of thrust towards the platform, i.e. another 42 tonnes and a total of 84 tonnes.

Again assuming the vessel operates between 10 to 30 m from the platforms, taking three points off the curve gave the following impact velocities.

Distance from platform	Impact Velocity
10 m	1.03 m/s
20 m	1.36 m/s
30 m	1.57 m/s
